POTOMAC
RIVERKEEPER®
NETWORK

April 30, 2020

Re: I-66/Route 123 Chain Bridge Road Construction Runoff Issues

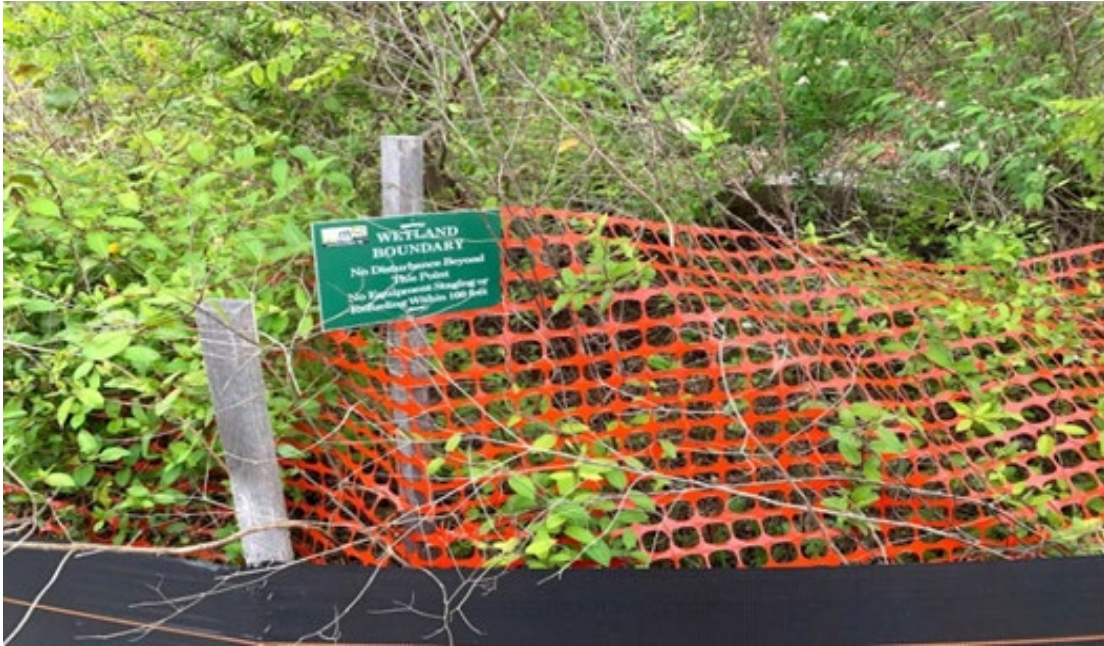
- 1) This protected “Wetland Boundary” sign indicates wetlands have been identified on the site plan and are being protected. There are no wetlands behind this orange protective fencing. There are two storm drain pipes, a partially daylighted stream and some small trees behind this very small area of orange fencing. Were there wetlands on the original site plan required to be protected? If so, they are gone. Why is VDOT claiming this is an area is protected wetlands?

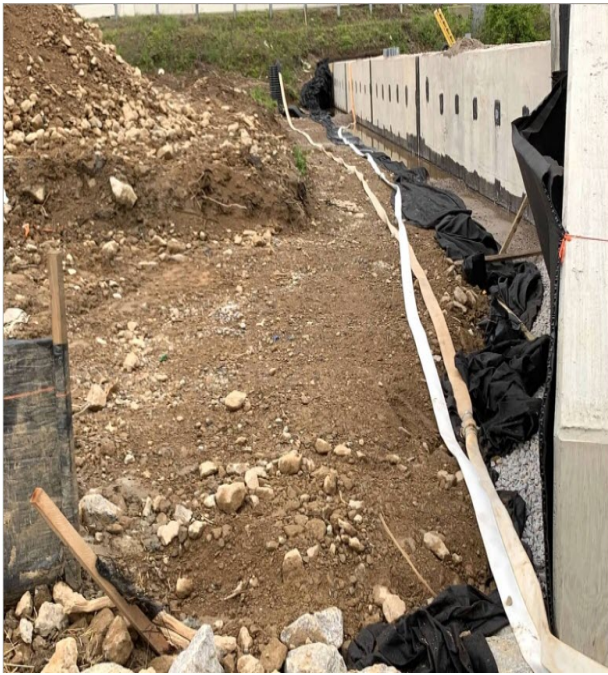
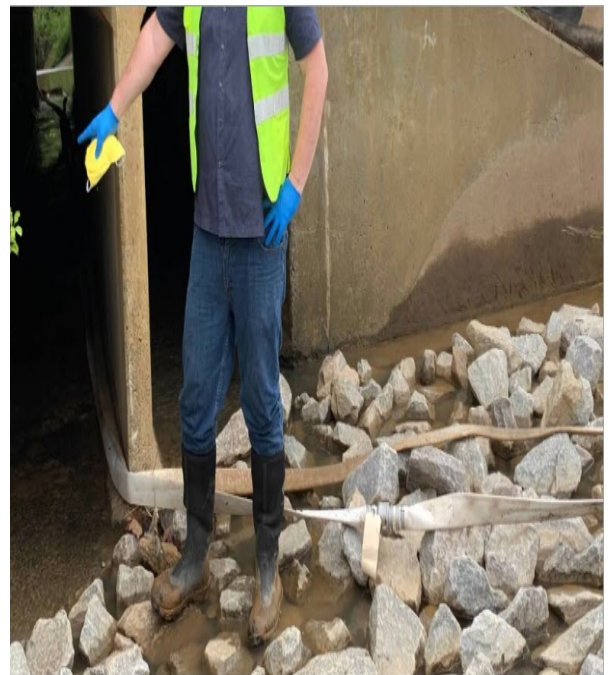
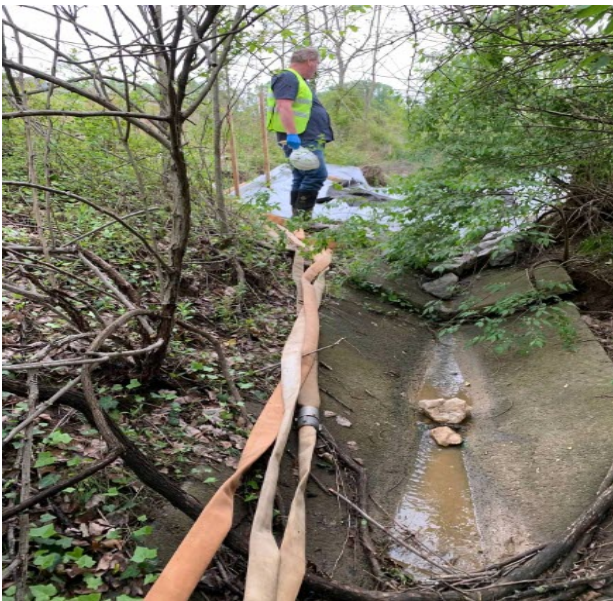
- 2) Additionally, the clover leaf on the east side of the I-66 East bound lane is the lowest part of the entire site (certainly one of them). There is a difficult stream crossing where sediment from the site is bypassing the concrete box culvert and entering a section of daylighted stream. It is evident there have been attempts by VDOT to try and prevent sediment from entering the stream based on this 2) unique pumping mechanism we identified on site. Hoses run the entire length of the culvert box drain (from the I66 westbound lane) which included an electric pump to pump sediment laden water down the stream bed under the I66 east lane. The hoses are laying right in the stream bed then turn 90 degrees and run up a steep slope on the other side of the highway where turbid water is pumped into dirt bags to help filter out the sediments. While we appreciate the extraordinary effort to develop this unique BMP, we have concerns the next big rain even these hoses will be washed down stream, potentially pulling the dirt bags and the sediment in them into the creek.

The electric pump was also disconnected when we were on the scene Friday evening 4/24 which means this, self-designed BMP only works when contractors are on site and when it is actually plugged into a generator. I personally don't feel this is an adequate solution. I find it hard to believe this was a BMP identified on the original site plan and approved by the state?

There were also major erosion issues at this end of the site. Bales of hay (not approved BMPs) were used to minimize sediment impacts to the stream. It was evident new land clearing activity was starting at this end of the site. Additional construction site activities can damage BMPs and cause additional runoff

issues in this already sensitive area. This low point will continue to experience off site sediment pollution and warrants special attention to adequately prevent sediment pollution from leaving the site.
